AMERICAN SOCIETY OF CIVIL ENGINEERS.
INSTITUTED 1852.

SHAFT SINKING UNDER DIFFICULTIES AT DOR-
CHESTER BAY TUNNEL, BOSTON, MASS.

By D. McN. STAUFFER, Member A. S. C. E.

READ SEPTEMBER 21ST, 1881.

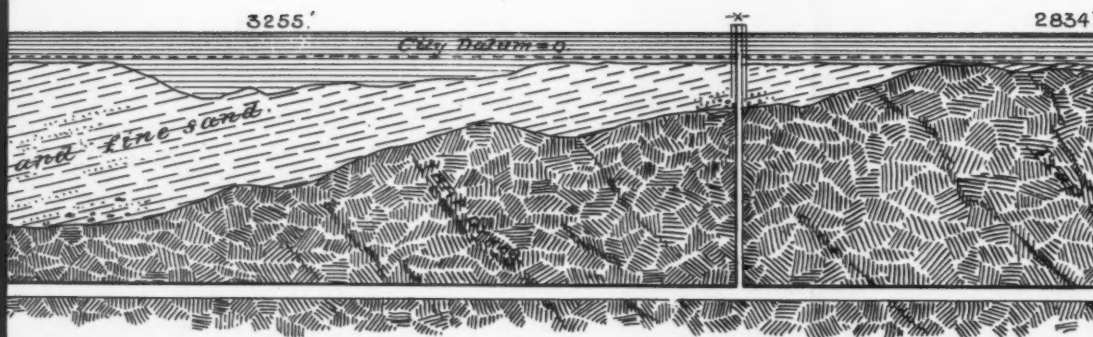
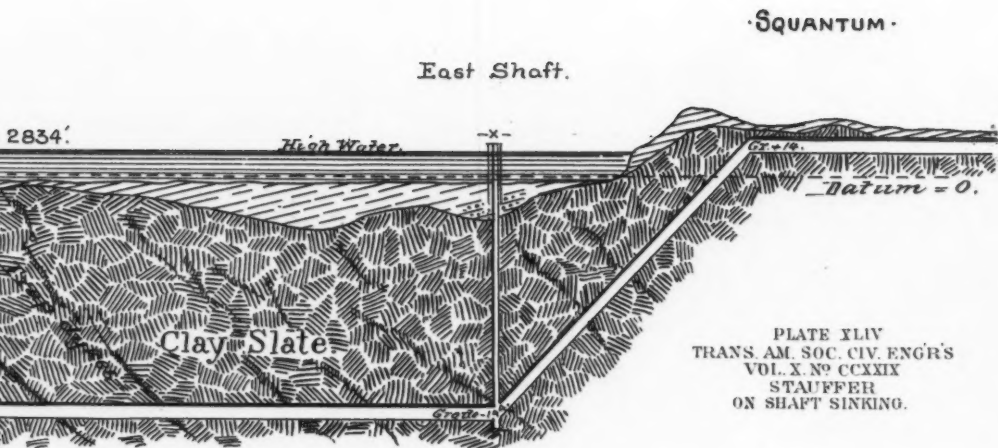
Profile Dorchester Bay Tunnel.

Plate XLIV, is a general profile of the tunnel, and shows the rock dipping rapidly from east to west. To meet this rock at as high an elevation as possible, the western, or inlet shaft, was pushed out about 1 400 feet from the Boston shore of the bay, and connection made between it and the pumping station, by a high-grade tank sewer, founded

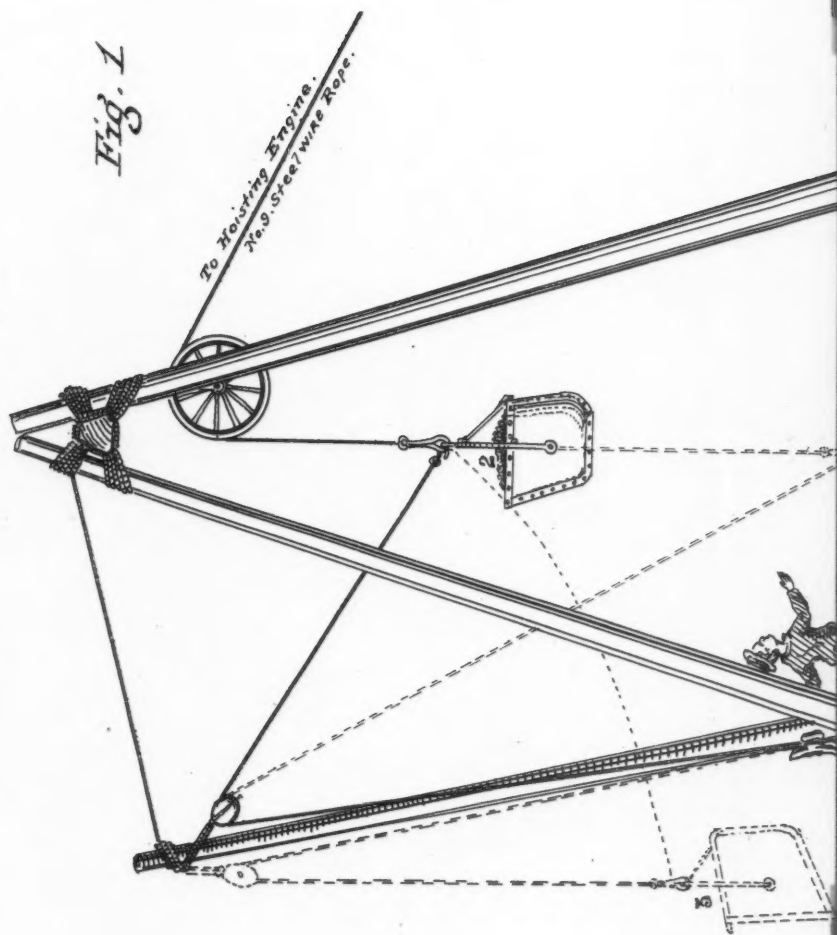
Fig. 1

HANDLING THE MATERIAL EXCAVATED.—Before the permanent hoisting cages were put in place, the material excavated in sinking the shafts, and in driving a considerable portion of the tunnel as well, was handled by an arrangement shown at Fig. 1, Plate XLV. This was simply an out-haul, working through a single block lashed to the head of a mast planted in the bulkhead; this mast leaned outward at the top—over the side of the bulkhead. In using this arrangement, the bucket is hoisted a distance above the shaft, fixed by experiment—the out-haul being hooked on to the bucket just as it reaches the mouth of the shaft—and the slack hauled in as the bucket ascends, when the bucket stops, the end of the out-haul is made fast to a cleat on the mast, and the bucket in descending will pass through a curve regulated by the length of the out-haul, until it hangs vertically from the top of the mast, and over the sides of the bulkhead, where it can be dumped. A reversal of this process will bring the bucket again to the top of the shaft, where the out-haul is unhooked, and the bucket lowered to the bottom for refilling.

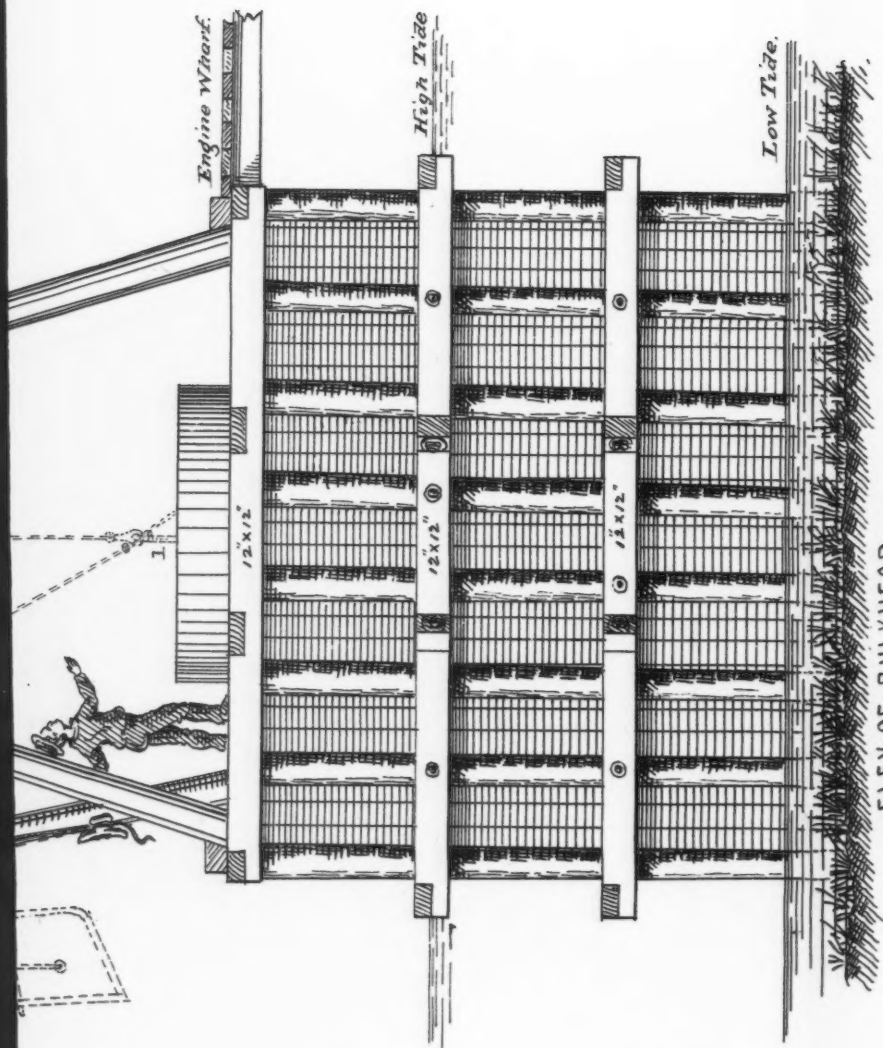
Fig. 2.

BULKHEADS ABOUT SHAFTS.—As all the shafts are located in water, from 3 feet to 15 feet in depth, depending upon the state of the tide, bulkheads were necessary, from which to commence operations, and to protect the mouth of the shaft from damage by storm, ice, passing vessels, &c. As shown at Figs. 1 and 2, Plate XLV, these bulkheads consisted substantially of a box 20 feet square inside, formed of oak piles driven $2\frac{1}{2}$ feet apart from centres, and capped by $12'' \times 12''$ hard-pine sticks, framed at the corners, and drift-bolted to the head of each pile. These caps were further secured at the corners by $12'' \times 12''$ angle-braces, dovetailed into them. The box was lined inside by 4-inches tongued and grooved sheet-piling, driven to hard bottom, and well spiked to four lines of $4'' \times 10''$ inside wale pieces. Outside of the piles were two sets of $12'' \times 12''$ hard pine timbers, spaced four feet apart vertically, and bolted to the piles by $1\frac{1}{4}$ -inch bolts, and tied at the corners of each set by 2" diagonal rods. The top of this bulkhead was 18 feet above mean low tide, the average rise and fall of tide being ten feet. After the iron cylinder had been started within this box, the space surrounding the cylinder was compactly filled with puddle clay.
